**PENETROMETER STUDY OF THE MACEDONIA
BAPTIST CHURCH, CHEROKEE COUNTY,
SOUTH CAROLINA**

Prepared By:
Michael Trinkley, Ph.D., RPA

Prepared For:
Macedonia Baptist Church
c/o Mr. James Goforth
849 S. Green River Rd.
Gaffney, SC 29341

February 5, 2007

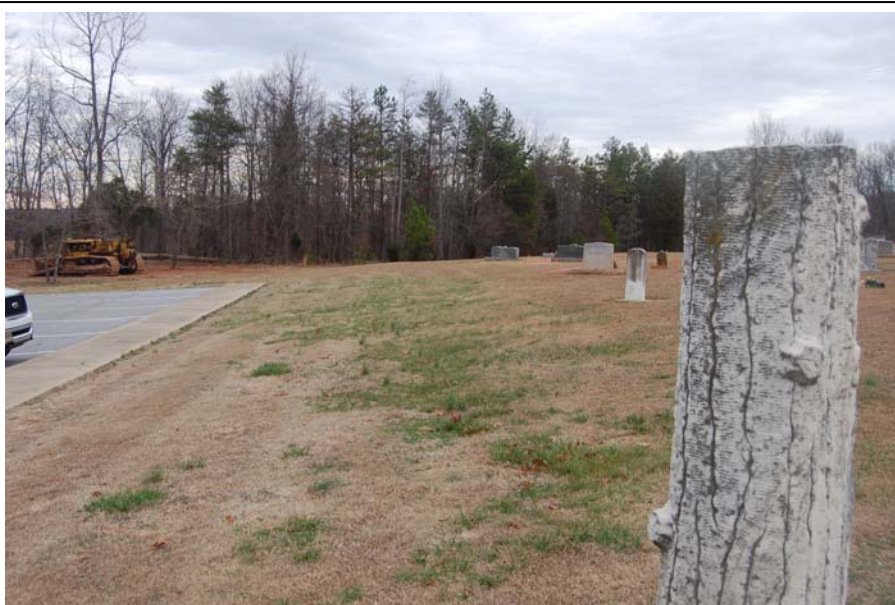
Figure 5. Area on the northwest edge of the cemetery showing grading and an absence of graves.

We found that no graves were identified along the outer northwest or southeast edges of the cemetery. To the northwest, along the edge of the parking lot, the topography has a swale and slope that is characteristic of grading. The compaction

levels (200 psi and higher) in this area are consistent with clay subsoils, perhaps with additional compaction through the use of heavy equipment. Not only were we not able to identify any areas of lower compaction that might represent graves, but the removal of 1-2 feet of soil would almost certainly have revealed coffin outlines. Thus it is highly unlikely that graves are found in these areas.

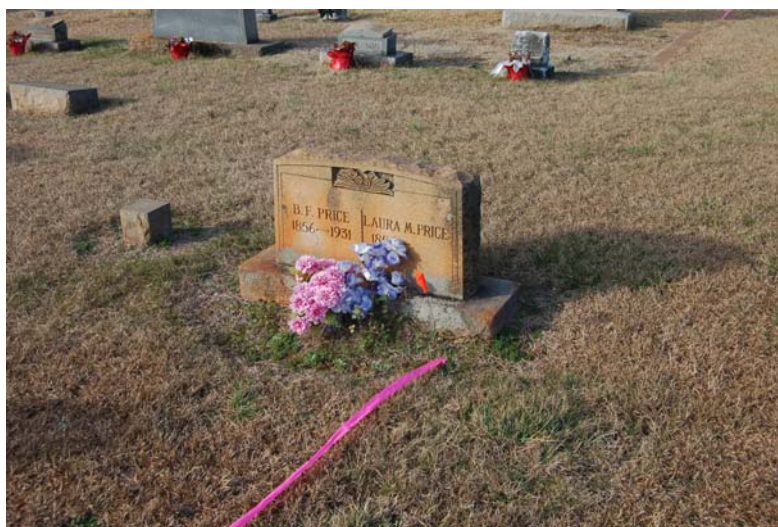
Figure 6. Although the stone has no death date engraved, the penetrometer study confirmed a burial.

We observed stones without death dates, but where the plot was shown to be occupied by the penetrometer. While relatives no doubt are aware that the plot has been filled, there is no obvious, public record without the stone being updated.

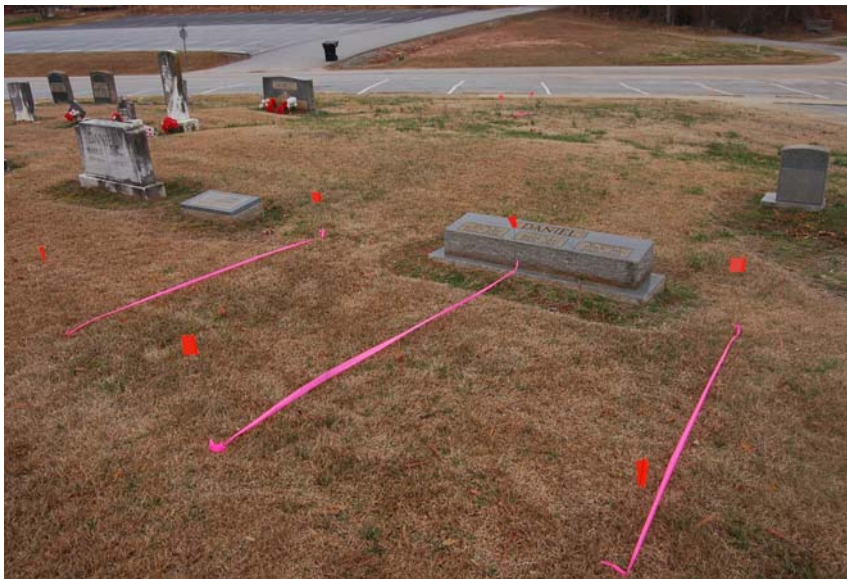
Figure 7. View of cemetery showing graves (marked with flags and flagging tape) identified by the penetrometer study.

probable graves. A total of 134 probable graves were marked during this assessment. Most occur as one, two, or three graves mixed among marked graves. Some appear to represent children, based on their size, and many children's graves went unmarked historically.

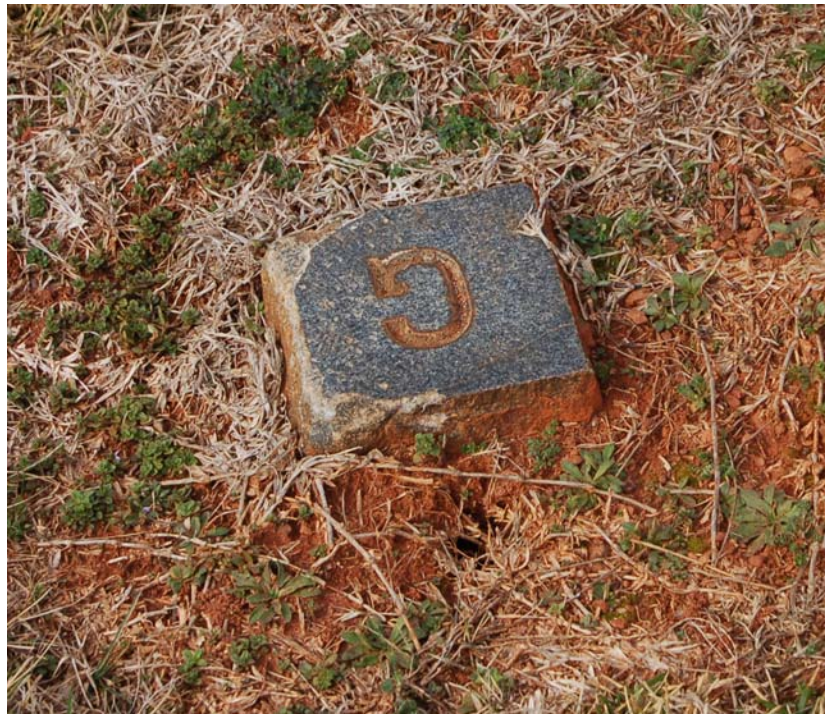
We observed a number of stones that evidenced damage as a result of mowing. The Church should ensure that a more sensitive and careful approach is taken.

Figure 8. Lawn maintenance problems. The top photo shows mower damage to a flush monument. The lower photo shows the results of herbicide use: increased weeds, disfigured landscape, and much splash back of clay from erosion.

There is extensive damage to markers from scalping during mowing, as well as impact by mowers. All mowers in the cemetery should have closed cell foam bumpers installed. Workers should be cautioned to slow down and take greater care. And the Church should have a representative approve all actions in the cemetery.

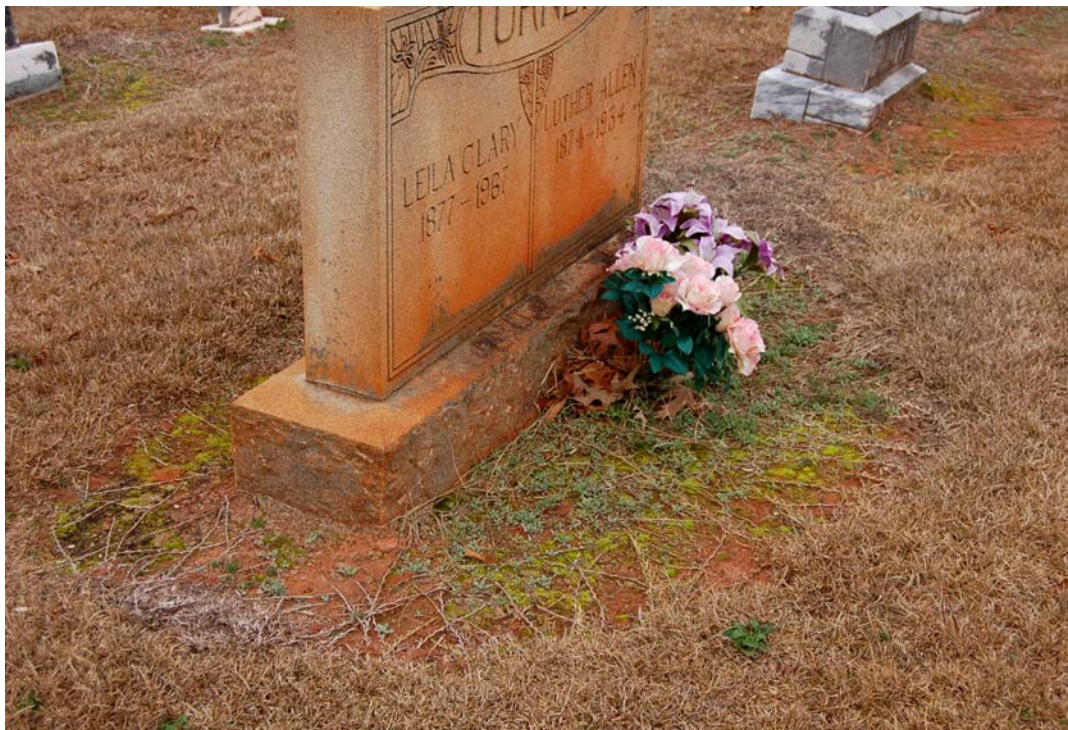
There is also abundant evidence that the lawn service has used a broad spectrum herbicide to kill the grass around stones and plots. This is a very bad practice and should cease immediately. It is disfiguring to the landscape, causing erosion around the stone, with much splash-back and staining of the stones. With the grass killed, it promotes a heavy weed infestation that will spread into the turfgrass. In addition herbicides contain salts that will, over time, cause serious damage to the stones. In the place of this poor management practice the lawn service should use

2. The use of herbicide to create “kill zones” around monuments must cease immediately. This is professionally unacceptable and is causing extensive damage to the landscape and the cemetery.

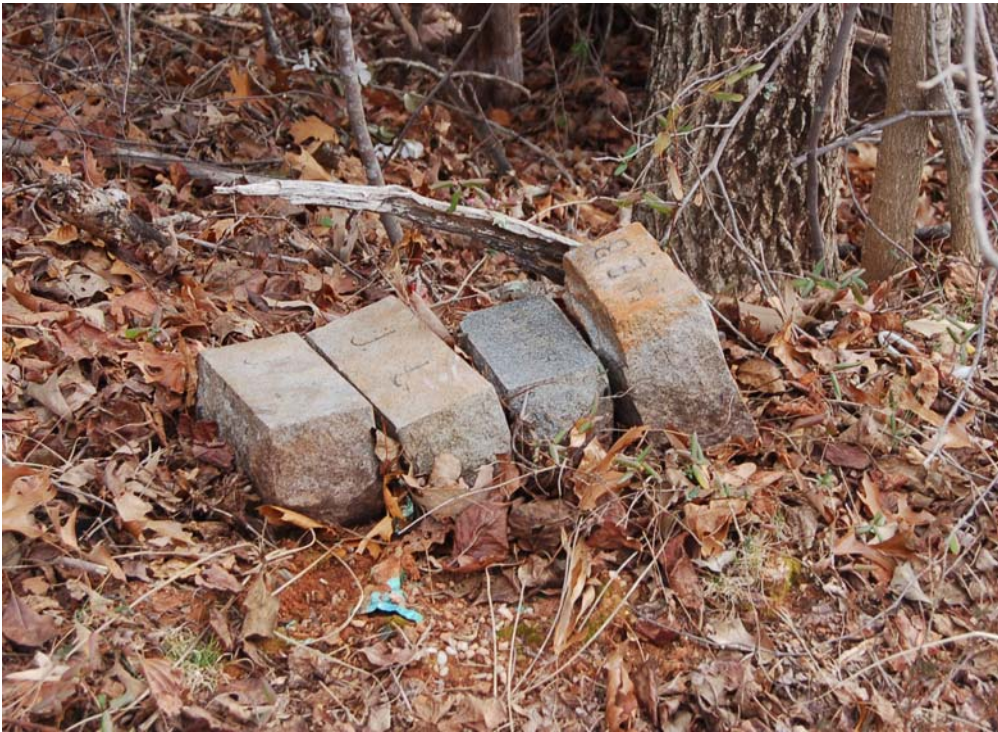
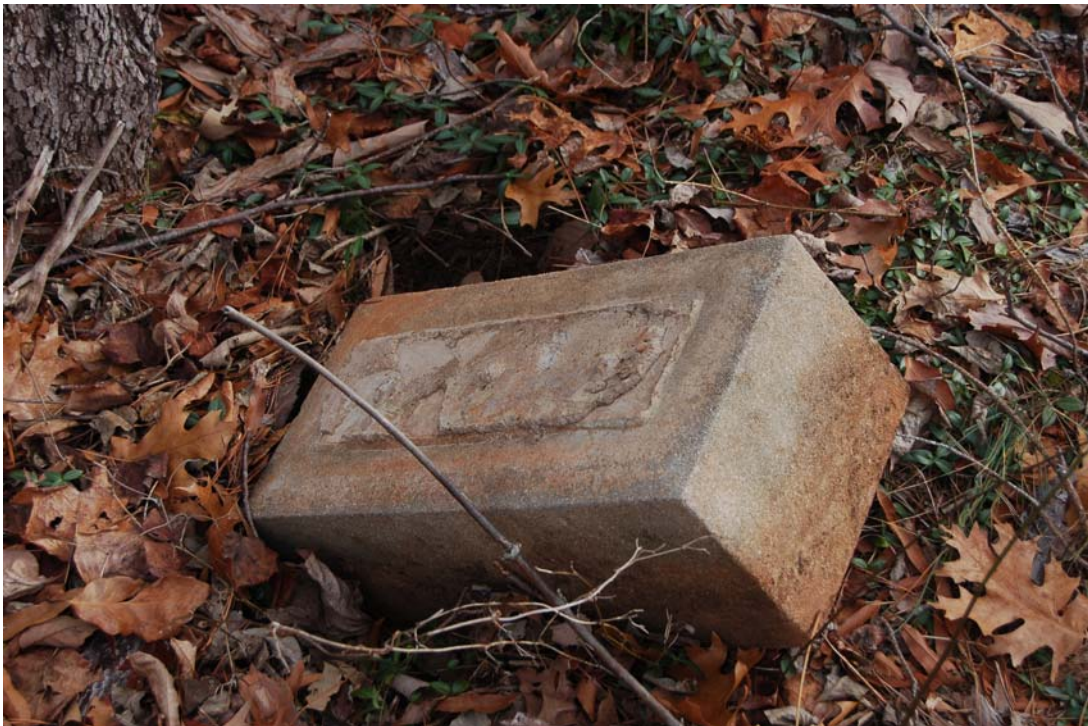
We observed numerous footstones, curbing, stone bases, and statuary discarded in the woods around the edge of the cemetery. This suggests that items were moved to allow backhoe access for the excavation of graves and then were discarded by the grave excavation service, rather than being replaced.

Figure 9. Markers discarded in the woods around the edge of the cemetery. This practice must cease immediately and these stones replaced in the cemetery.

4. There is evidence that the firms retained to excavate burial pits have been discarding markers that have been in their way. This is an unacceptable practice that must cease immediately. We recommend that the Church oversee all future excavations and require immediate repair of any damage. If backhoes are unable to operate in a safe and respectful manner in the cemetery, then the Church should require hand excavation of all graves – a practice that is actually quite common in historic cemeteries.

An effort should be made to replace those elements that have been discarded.

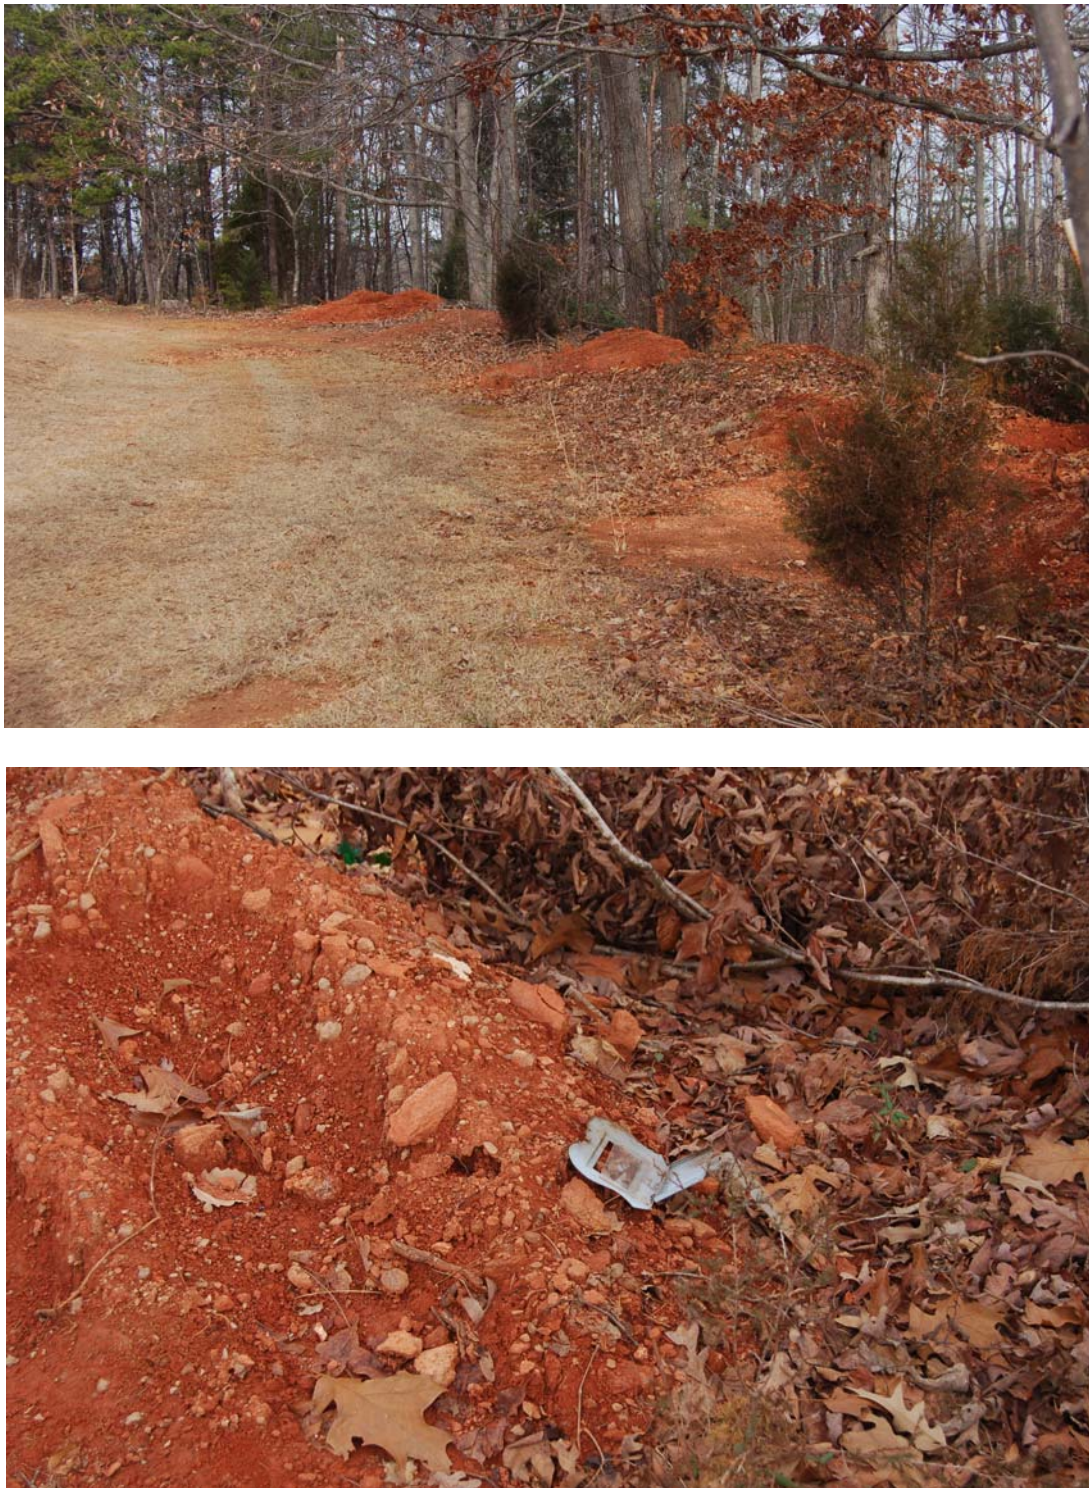
Figure 10. Spoil piles at the edge of the cemetery. In one we identified the remains of a funeral home plate that had been removed with the spoil – effectively losing this burial information.

We also observed large mounds of spoil, resulting from the use of vaults. This spoil should not be placed at the edge of the cemetery. It disfigures the landscape and detracts from the beauty of the cemetery. Burial firms should be directed to remove all spoil (or the church may direct its disposal in other areas). Again, any firm violating this requirement should be prohibited from doing future work or a bond should be required.

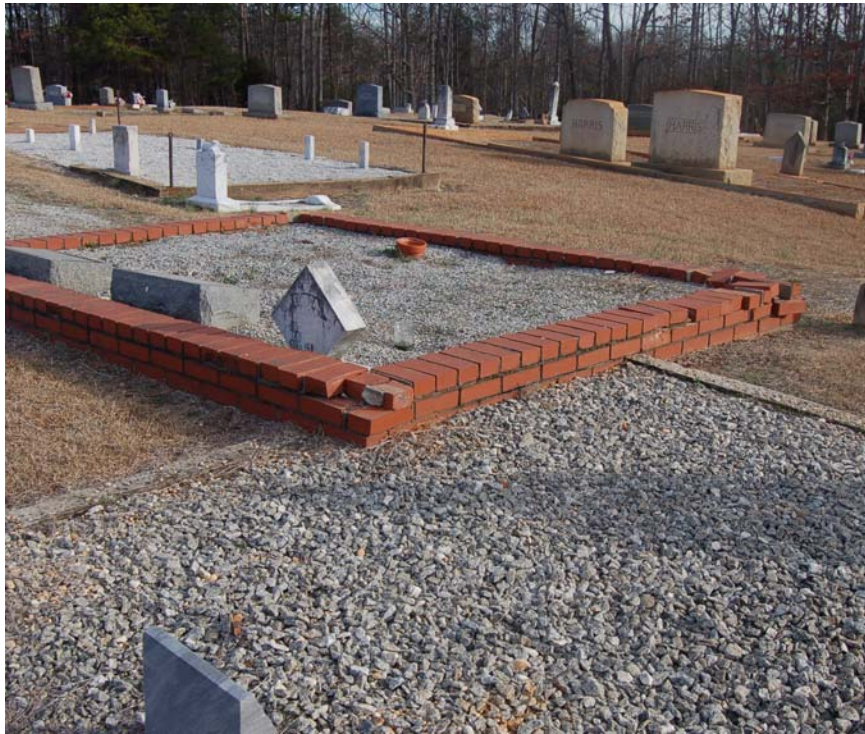
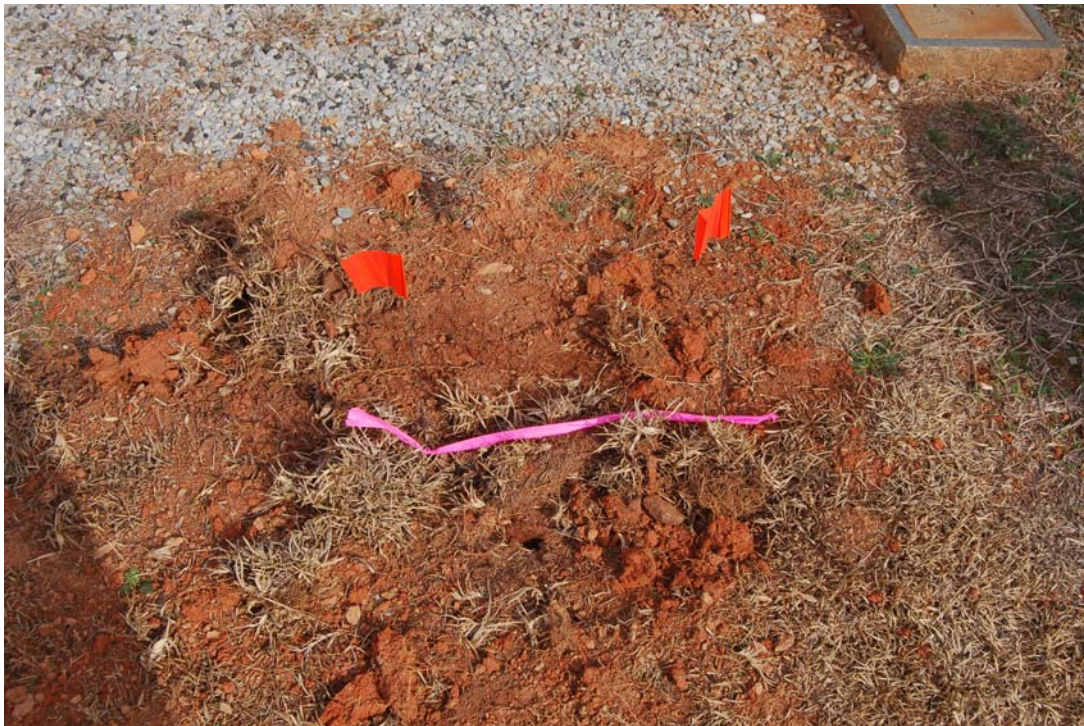
Figure 11. The top photo shows one plot built over another. The lower shows cremains placed in the cemetery without the knowledge of the church.

made without any prior arrangement with the church. This is not only obvious by the poor workmanship of the burial excavation firms, but also by the discovery of a stone with no associated grave and an excavation for cremains about which the church was unaware.

3. All burials and burial locations in the cemetery must be authorized in advance by the church. The laissez faire approach exercised thus far has caused plots to overlap and for plots to be placed between pre-existing rows.

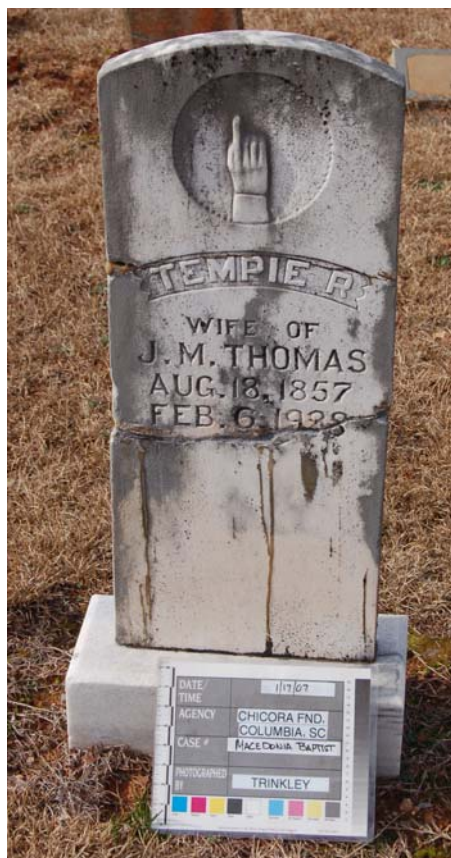
Figure 12. Example of unacceptably repaired stone. The stone is poorly matched on the sides and there is much epoxy left dribbling down the face of the marker.

We observed several stones that had been repaired in the past. In general these repairs are poorly executed, resulting in additional damage to the stone. The church should assist families in locating appropriate repair assistance. In general, monument companies, while familiar with modern stone are neither trained in, nor do they have the expertise, to repair historic stone.

Repairs should be conducted by trained stone conservations who subscribe to the code of ethics and standards of practice of the American Institute for Conservation (AIC).

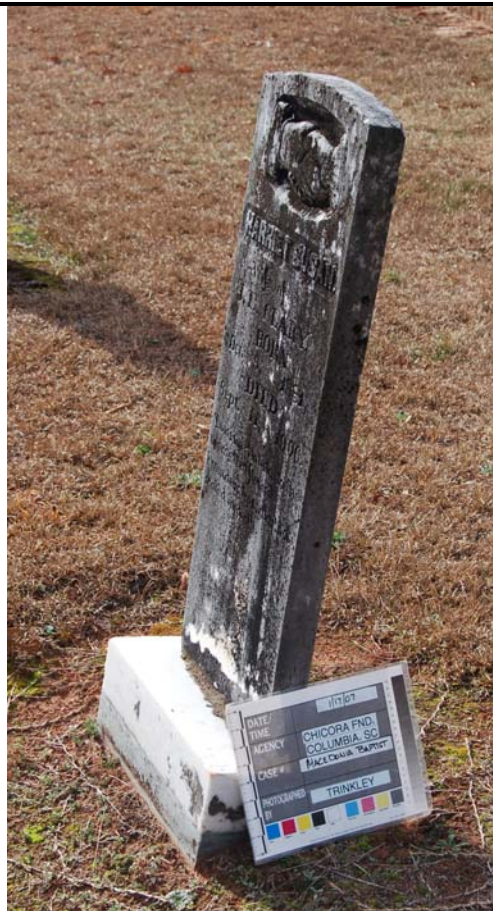
Marble tab in socket. Stone is well set in socket, but die is poorly set, resulting in the stone being out of plumb by about 15°. This puts additional stress on the stone and contributes to the stone breaking. The monument also exhibits heavy atmospheric staining, likely gypsum crust. Moderate biologicals.

Stone will be reset in a pea gravel footing. This will promote drainage away from the stone and will also allow some movement should the stone be impacted by lawn maintenance or other activities. Once reset the stone will be cleaned with D/2 Architectural Antimicrobial and flushed with potable water.

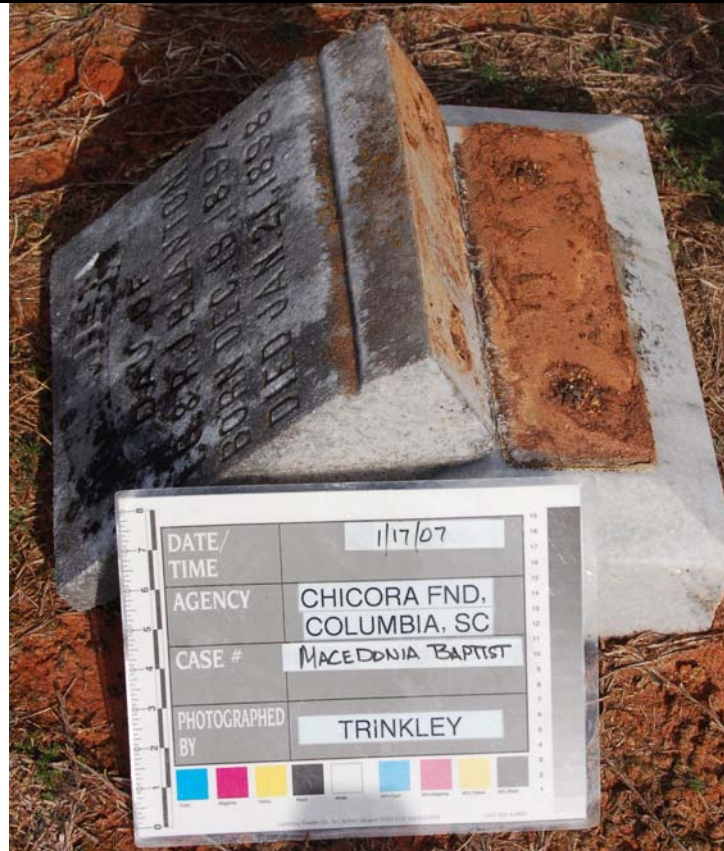
Marble die on base with two ferrous pins, both broken and exhibiting extensive iron jacking. The die is no longer stable on the base. The base is no longer set level. Moderate atmospheric staining and moderate biologicals. Some iron staining from the ferrous pins and the clay. These iron pins must be removed or they will continue to corrode and will eventually spall the stone.

A diamond core drill will be used to remove the four ferrous pin stubs. The base will be leveled in pea gravel to promote drainage and to allow some movement should the stone be impacted by lawn maintenance or other activities. The ferrous pins will be replaced with threaded 316 stainless steel pins. These pins will be adhered in the lower holes only using a hi-mod, moisture insensitive structural epoxy. A 1:3 mix of NHL 3.5 and sand will be used to reset the stone. After curing the stone will be washed using D/2 Architectural Antimicrobial and flushed with potable water.

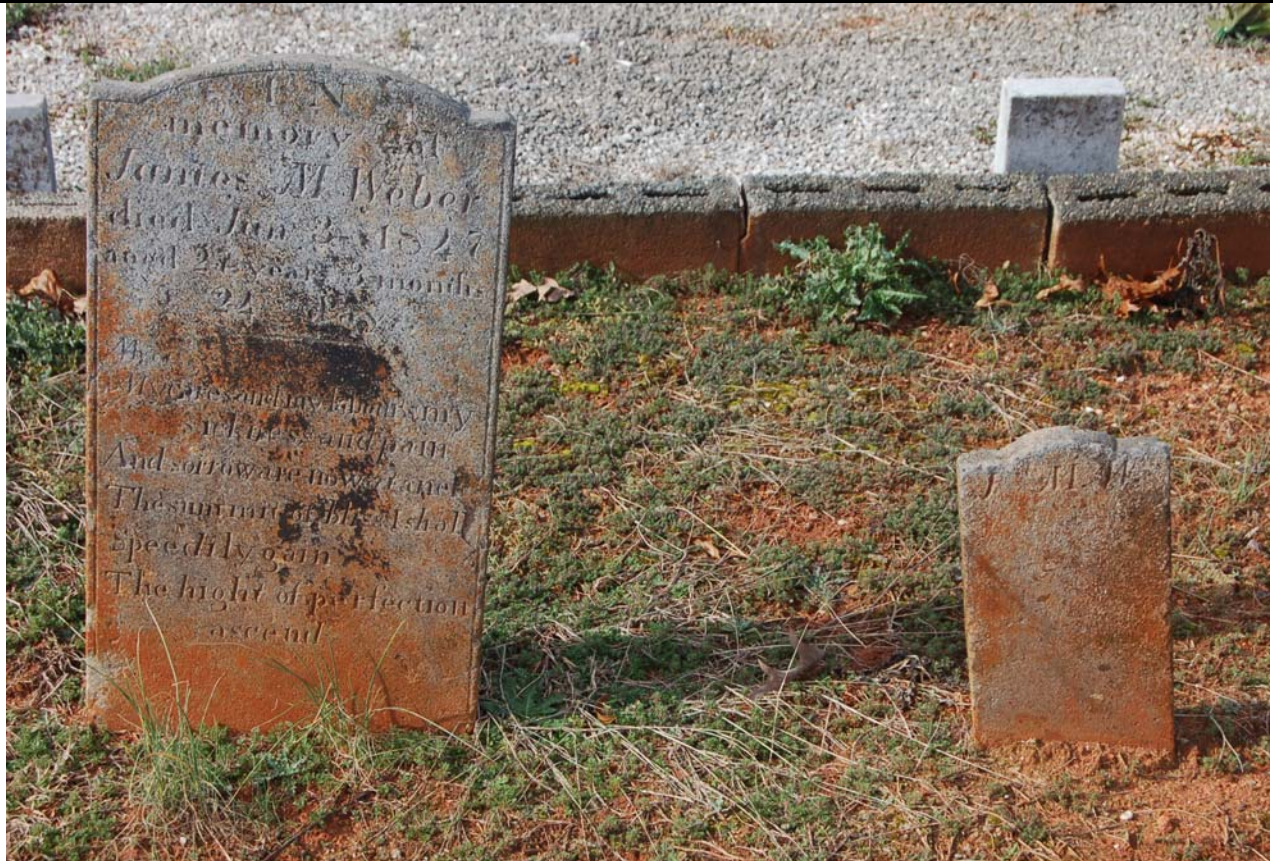
Statite headstone and footstone. The footstone has been improperly set (likely to allow easier mowing) and requires appropriate placement. Both are heavily stained by clay. The headstone exhibits black staining of unknown origin which requires testing for removal. This represents one of the earlier stones (1847) and is particularly valuable.

The footstone will be excavated and replaced ca. 5-feet from the headstone, set in a pea gravel footing. This will promote drainage away from the stone and will also allow some movement should the stone be impacted by lawn maintenance or other activities. Several cleaners will be tested on the black material found on the headstone to determine the best cleaning approach. The selected product will be used to remove the stains.

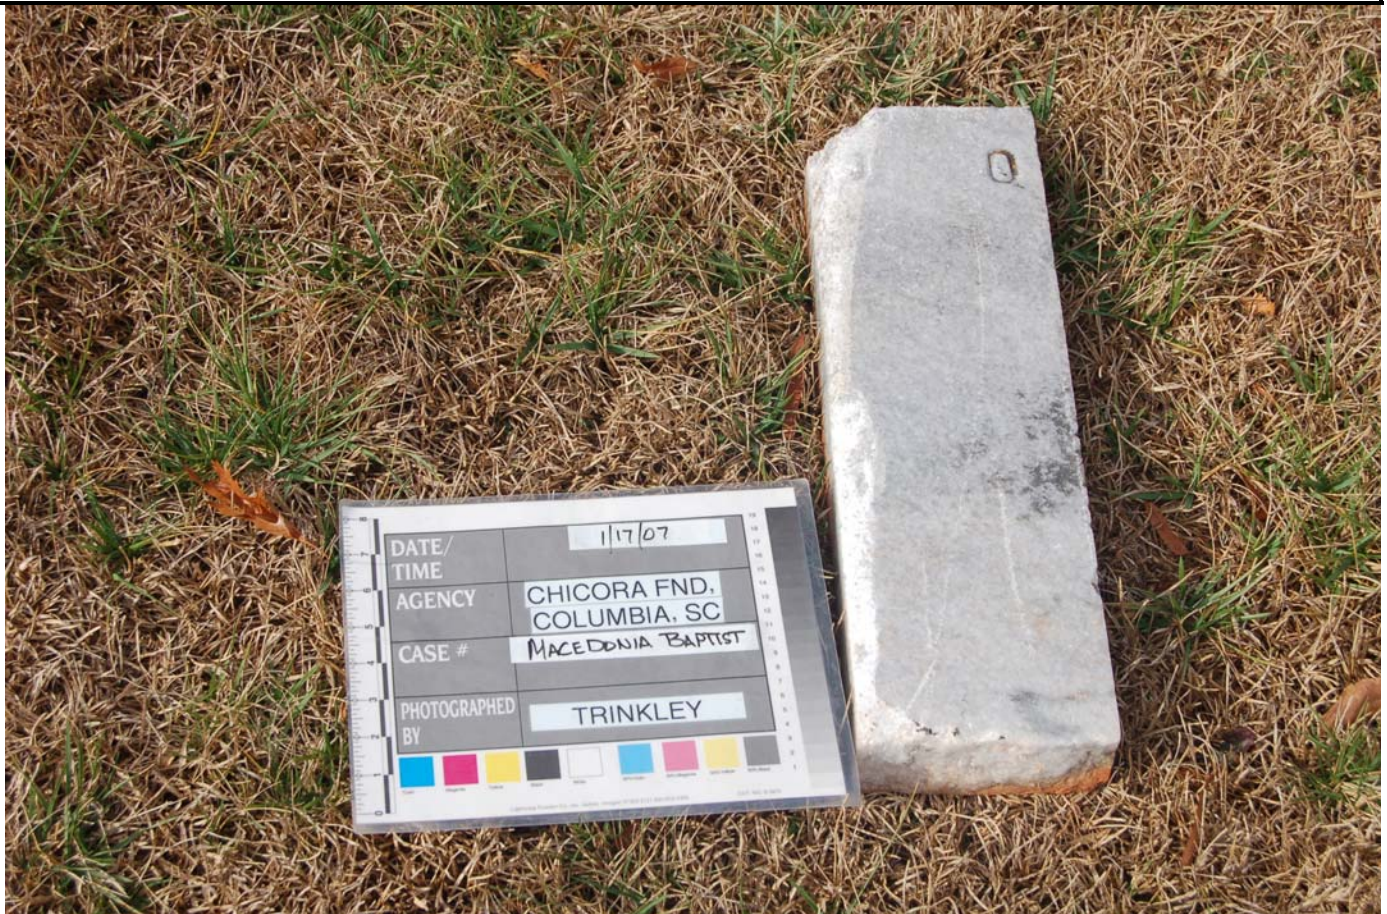
Marble footstone out of the ground and lying on the surface, subject to damage or theft. Stone requires resetting. Afterwards the stone will be cleaned using D/2 Architectural Antimicrobial and flushed with potable water.

The footstone will be paired with its headstone and reset ca. 5 feet below the headstone in a pea gravel footing. This will promote drainage away from the stone and will provide some movement should the stone be impacted by lawn maintenance or other activities. Afterwards the stone will be cleaned with D/2 Architectural Antimicrobial and flushed with potable water.

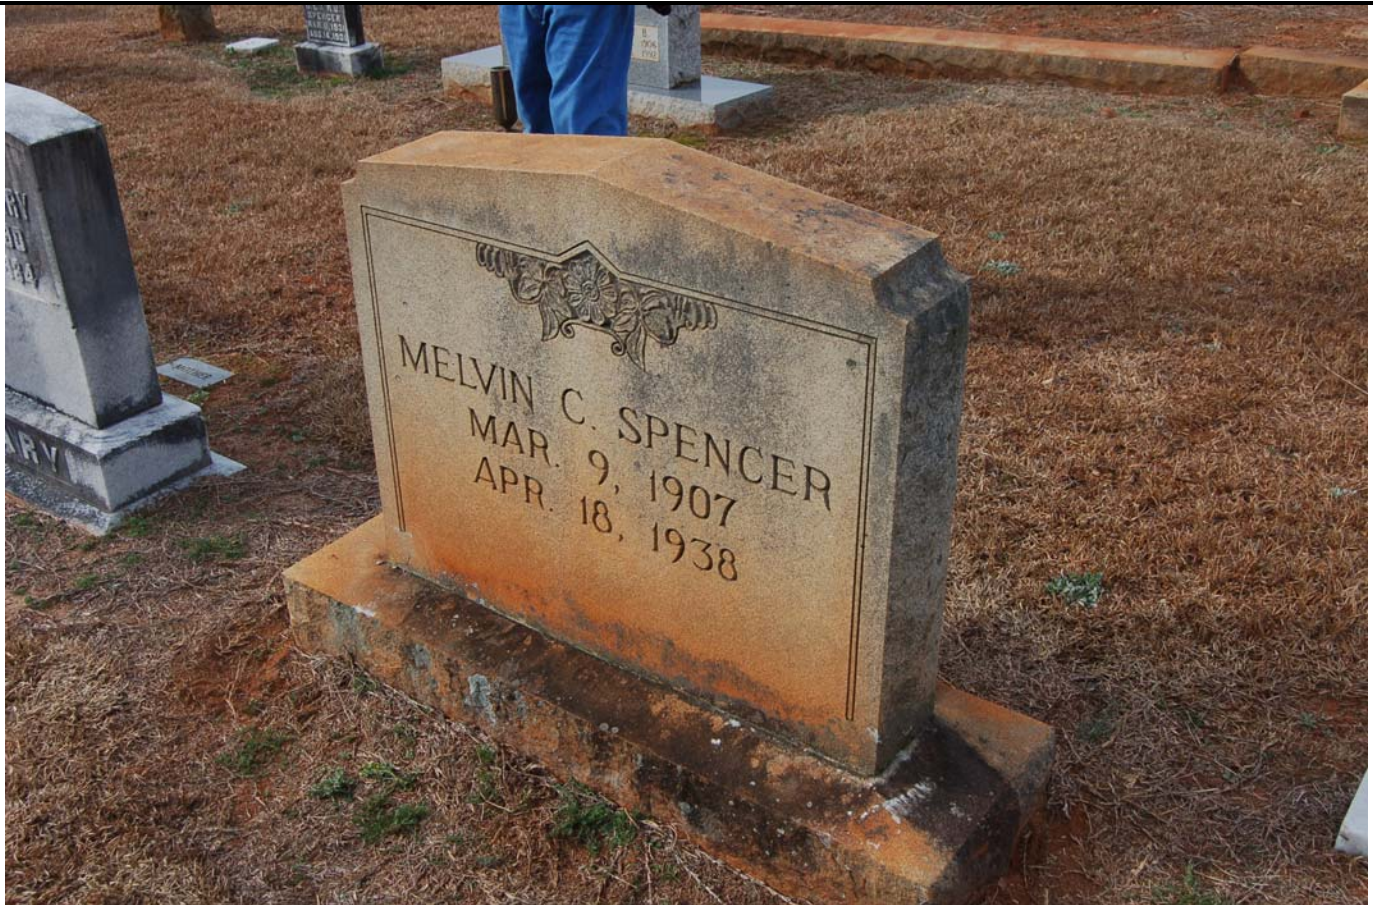
Granite die on base. The die is no longer attached to the base and is unstable. Much old setting compound on the die and base. Moderate biologicals overall.

Granite die will be removed, allowing the base of the die and the top of the base to be cleaned of adhering setting compound. The die will be reset using proprietary setting compound designed for granite markers. The stone will be cleaned using D/2 Architectural Antimicrobial and flushed with potable water.

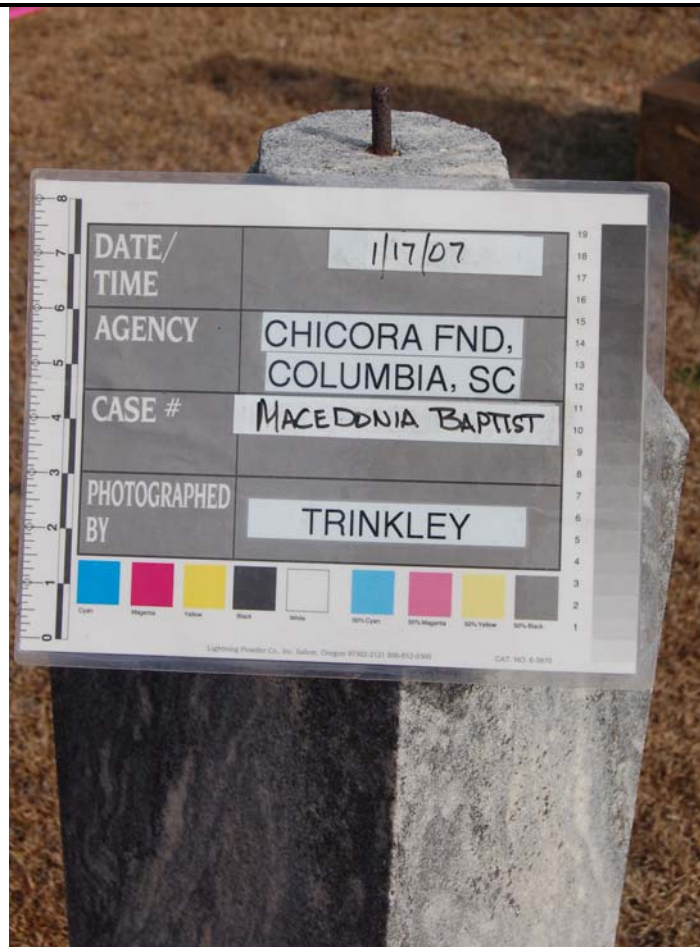
Marble pedestal tomb with missing finial. There is a ferrous pin still in place which require removal. Otherwise biologicals and atmospheric staining are light. Monument appears stable.

The ferrous pin will be core drilled out and the hole will be infilled with Jahn M120 Marble Mortar. After setting the stone will be cleaned using D/2 Architectural Antimicrobial and flushed with potable water.

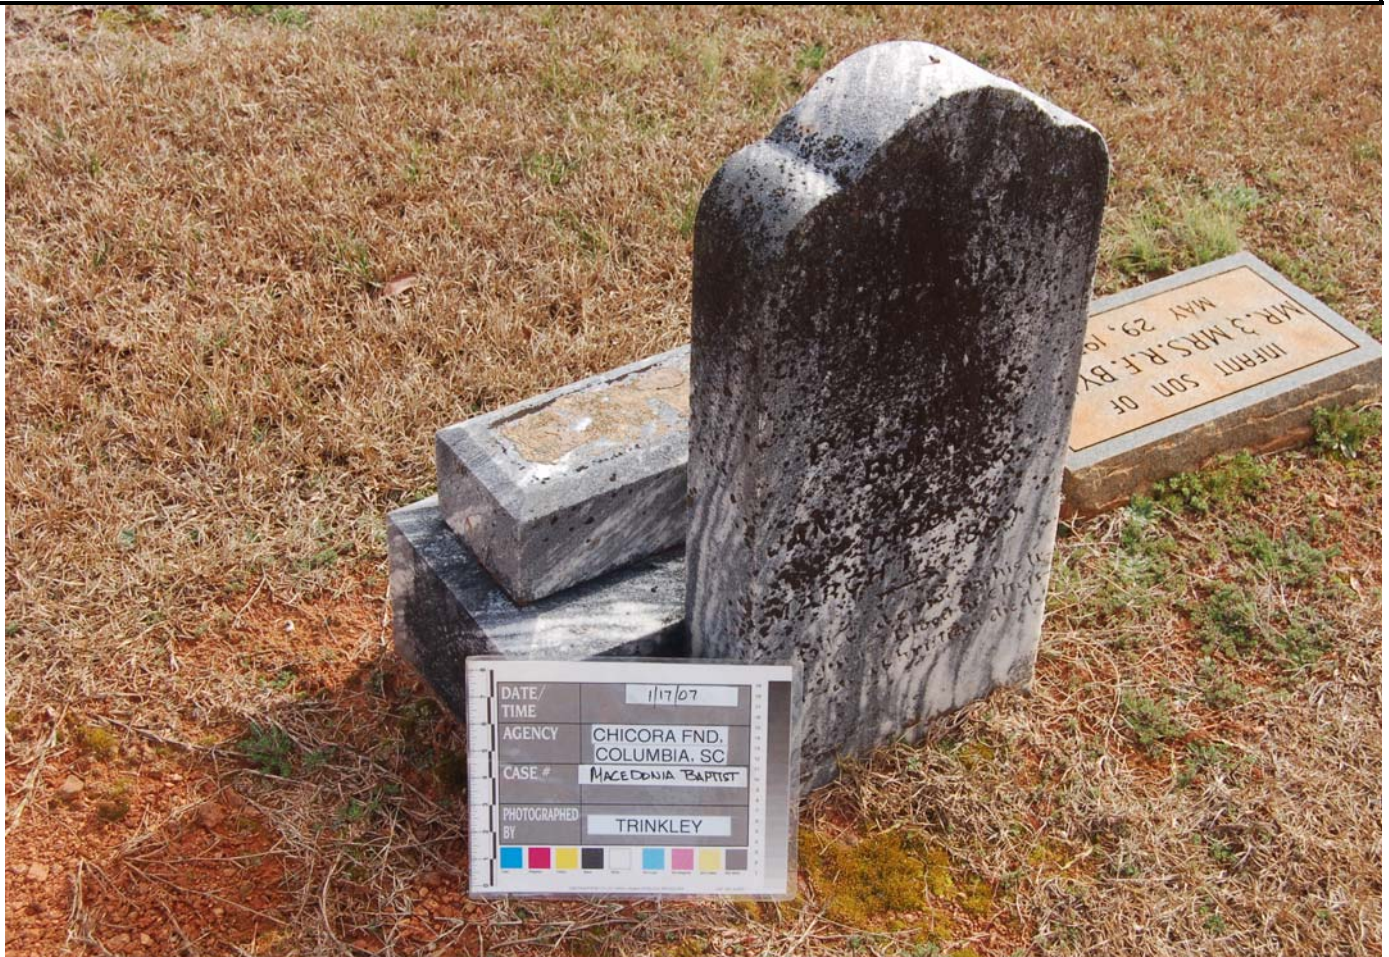
Marble die on base. Die has fallen, middle base is loose. There are no pins. Base requires leveling. Heavy biologicals overall.

Base will be reset in pea gravel to promote drainage away from the stone and to allow some movement should the stone be impacted by lawn maintenance or other activities. The base, middle base, and die will be drilled for insertion of two 5/8-inch threaded 316 stainless steel pins to connect them. These pins will be set using a hi-mod, moisture insensitive, structural epoxy. Each base will be set using a 1:3 mix of NHL 3.5 and sand. Once set the stone will be cleaned using D/2 Architectural Antimicrobial and flushed with potable water.

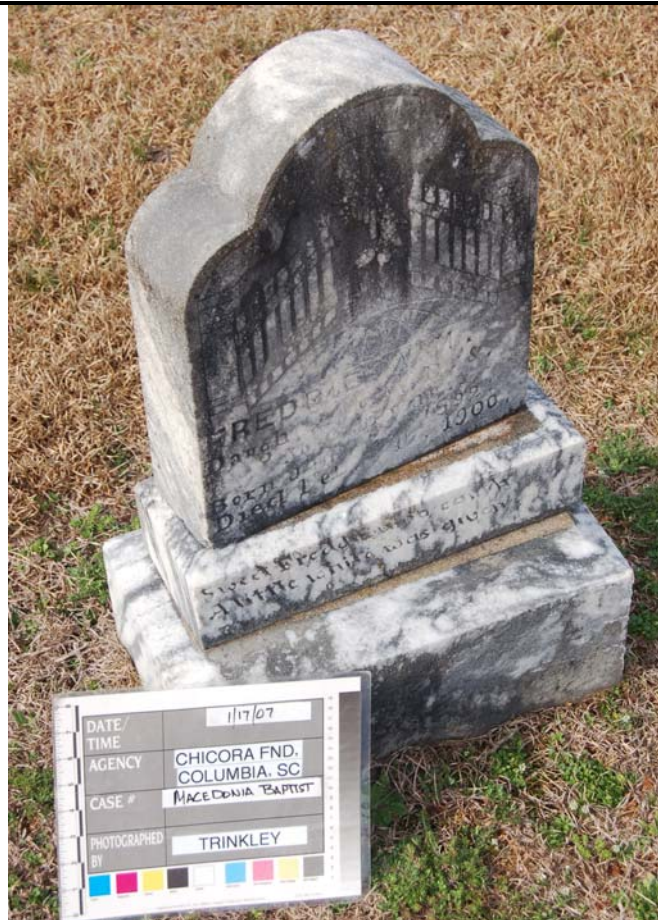
Marble die on base. Die and middle base are loose. There are no pins. Base requires leveling. Moderate biologicals overall.

Base will be reset in pea gravel to promote drainage away from the stone and to allow some movement should the stone be impacted by lawn maintenance or other activities. The base, middle base, and die will be drilled for insertion of two 5/8-inch threaded 316 stainless steel pins to connect them. These pins will be set using a hi-mod, moisture insensitive, structural epoxy. Each base will be set using a 1:3 mix of NHL 3.5 and sand. Once set the stone will be cleaned using D/2 Architectural Antimicrobial and flushed with potable water.

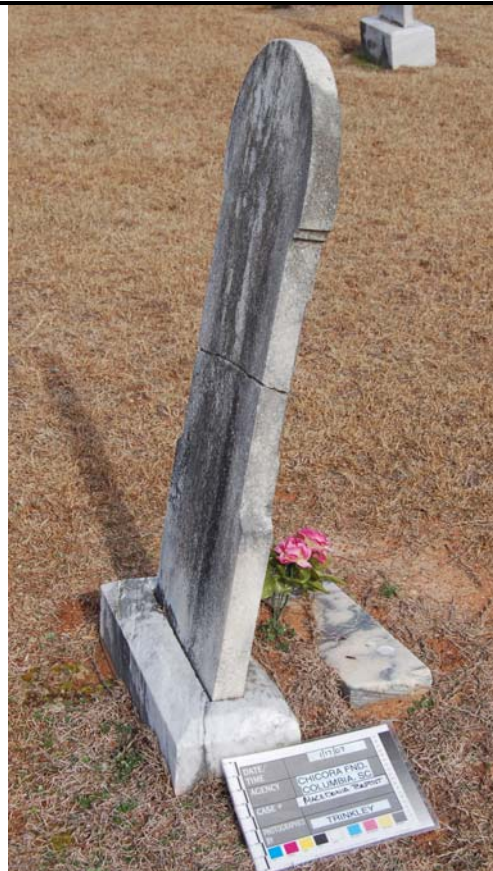
Marble tab in socket. There is an old break mid-way up the die; this appears to have received a simple epoxy repair which, at present, is stable. The die, however, is loose in the socket, allowing the stone to lean and this is putting additional stress on the old repair. Treatment has a high priority to prevent additional damage to this stone. The footstone has also been removed and is lying at the base of the headstone. Moderate biologicals and atmospheric staining overall.

The die will be removed from the base, allowing the base to be reset if necessary. Both the footstone and base of the headstone, if necessary, will be reset in pea gravel to promote drainage away from the stone and allow some movement should the stone be impacted by lawn maintenance or other activities.

Should the old repair fail during resetting additional treatment, consisting of mechanical removal of the old epoxy, and drilling the stone for the insertion of two threaded 316 stainless steel pins ½-inch in diameter and about 18 inches in length. These will be set using a hi-mod, moisture insensitive structural epoxy. Registration will be checked and the two fragments will be clamped to allow the epoxy to cure for 24-48 hours. The cost of this work is not included in the estimate below, but will add approximately \$375 to the total cost.

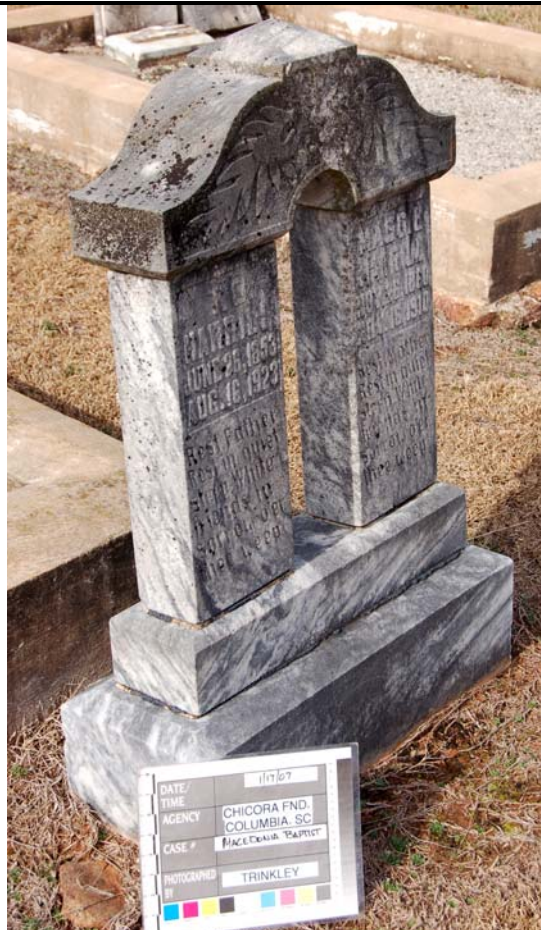
Marble arched pedestal tomb. All components are loose. Ferrous pins are present in at least the columns. Monument is severely leaning. Moderate atmospheric staining and biologicals, notably at the top.

Monument will need to be disassembled to the base, which requires resetting in pea gravel to level. This will promote drainage away from the stone and will allow some movement should the base be impacted by lawn maintenance or other activities.

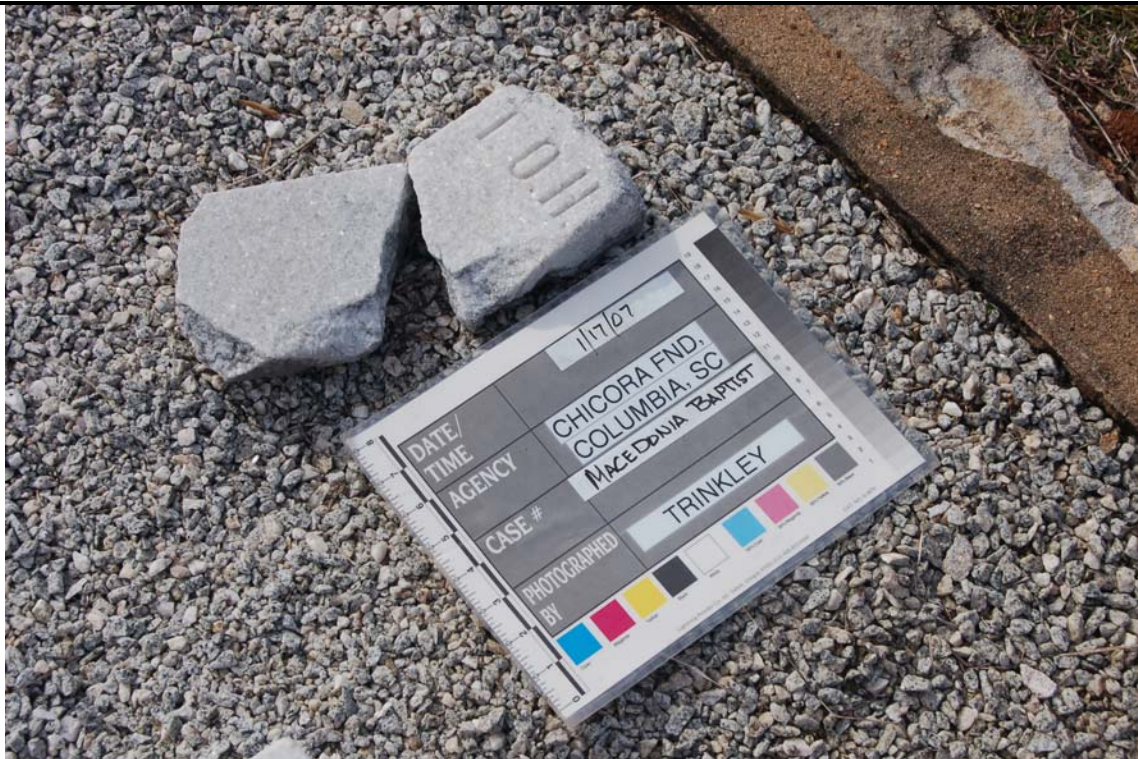
Marble footstone broken into three fragments (one is likely still below grade). No biologicals.

The lower portion of the footstone will be identified through probing and removed for repair.

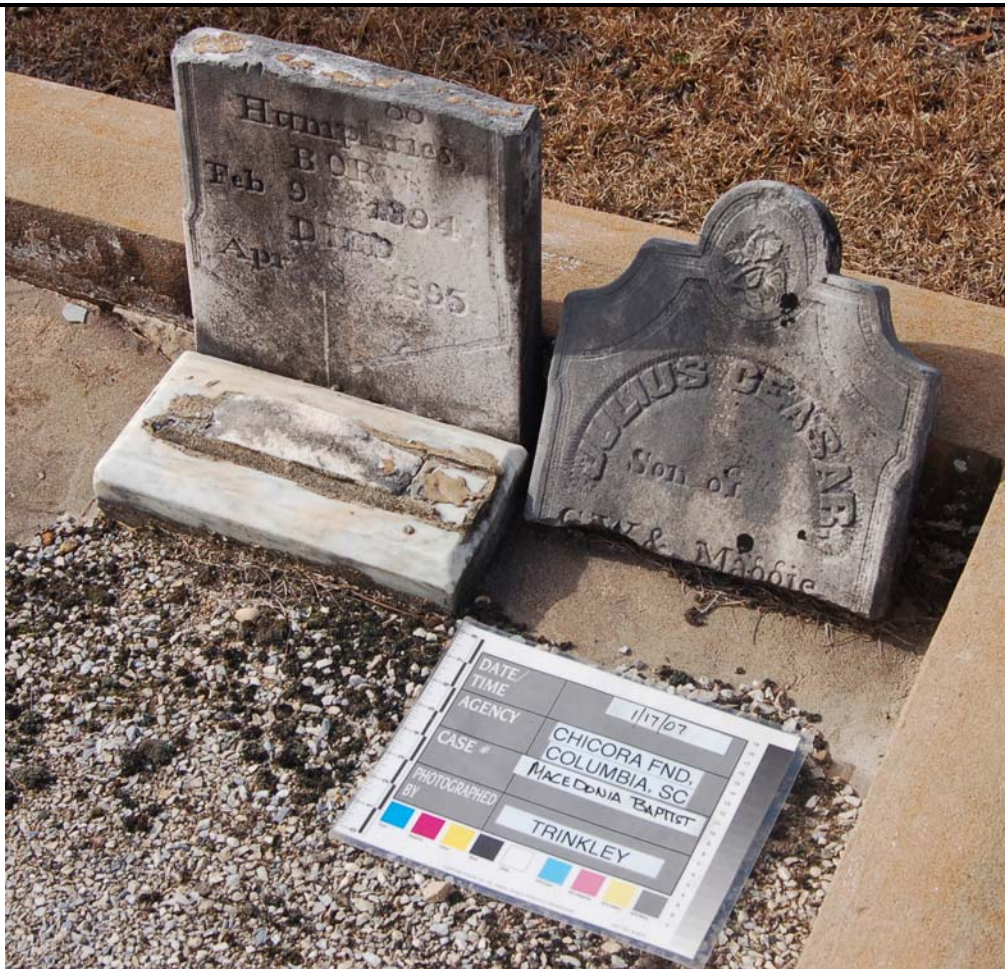
Marble tab in socket with two breaks – one at socket and another mid-way up the stone. Both evidence old, failed repairs and the parts are currently set in the plot. Moderate biologicals, heavy atmospheric staining.

All old repair material will require mechanical removal.
